## **APPENDIX A**

### **AIR QUALITY**

# Idaho State Veterans Home - Boise

STATE HISTORIC PRESERVATION OFFICE  
COMMUNITY PRESENTATION

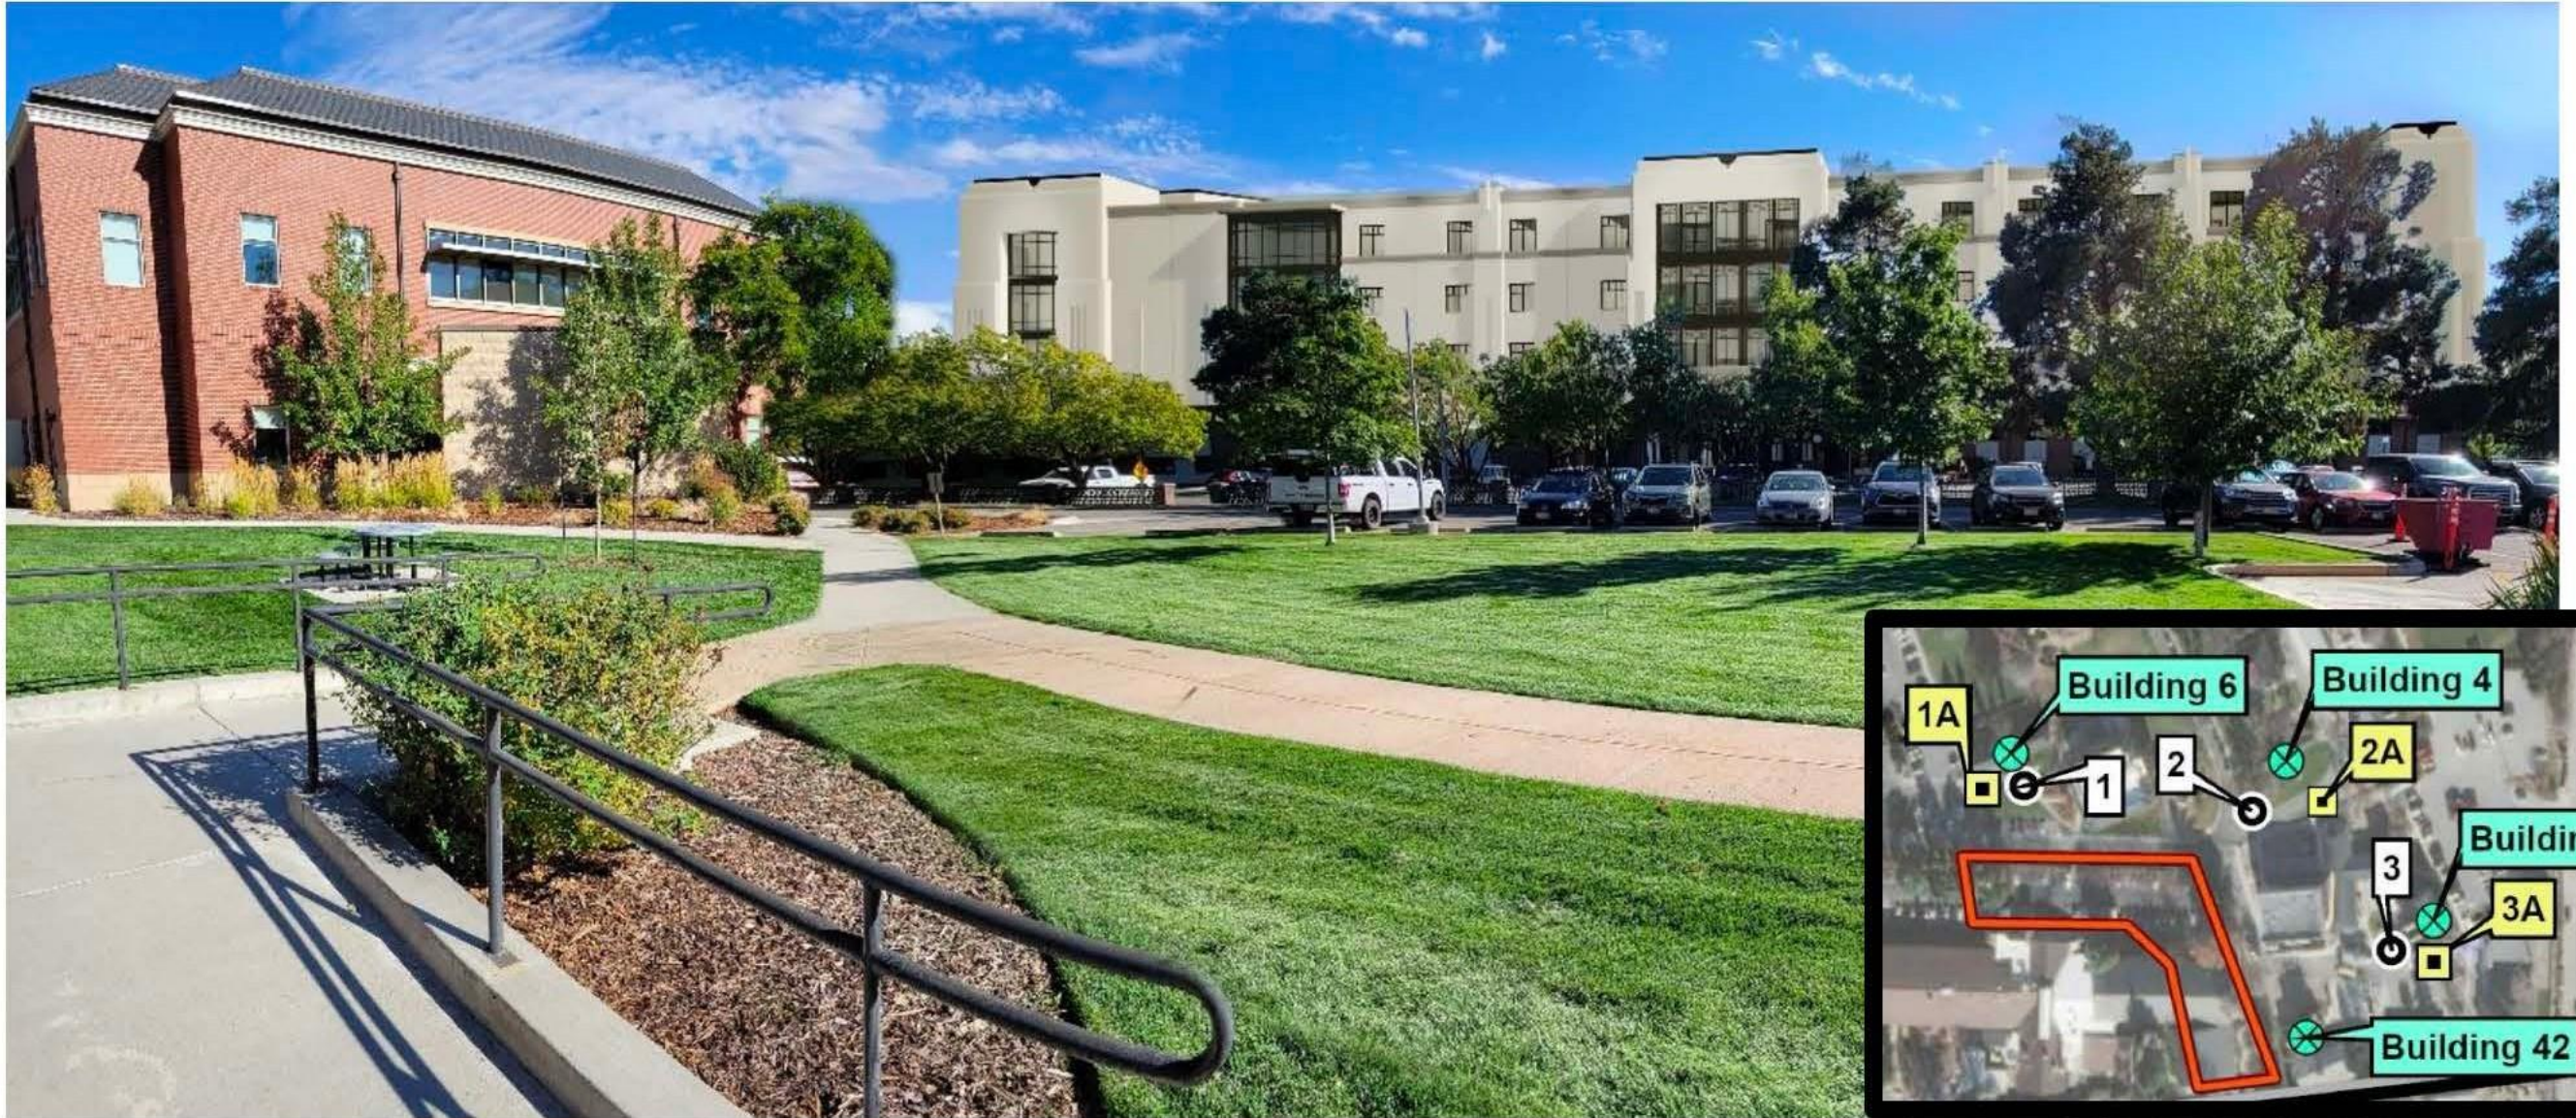
**Figure A-4. View of proposed building from Building 6 (rendering view 1A, Figure 2-A), looking south/southeast (image courtesy of Orcutt/Winslow).**

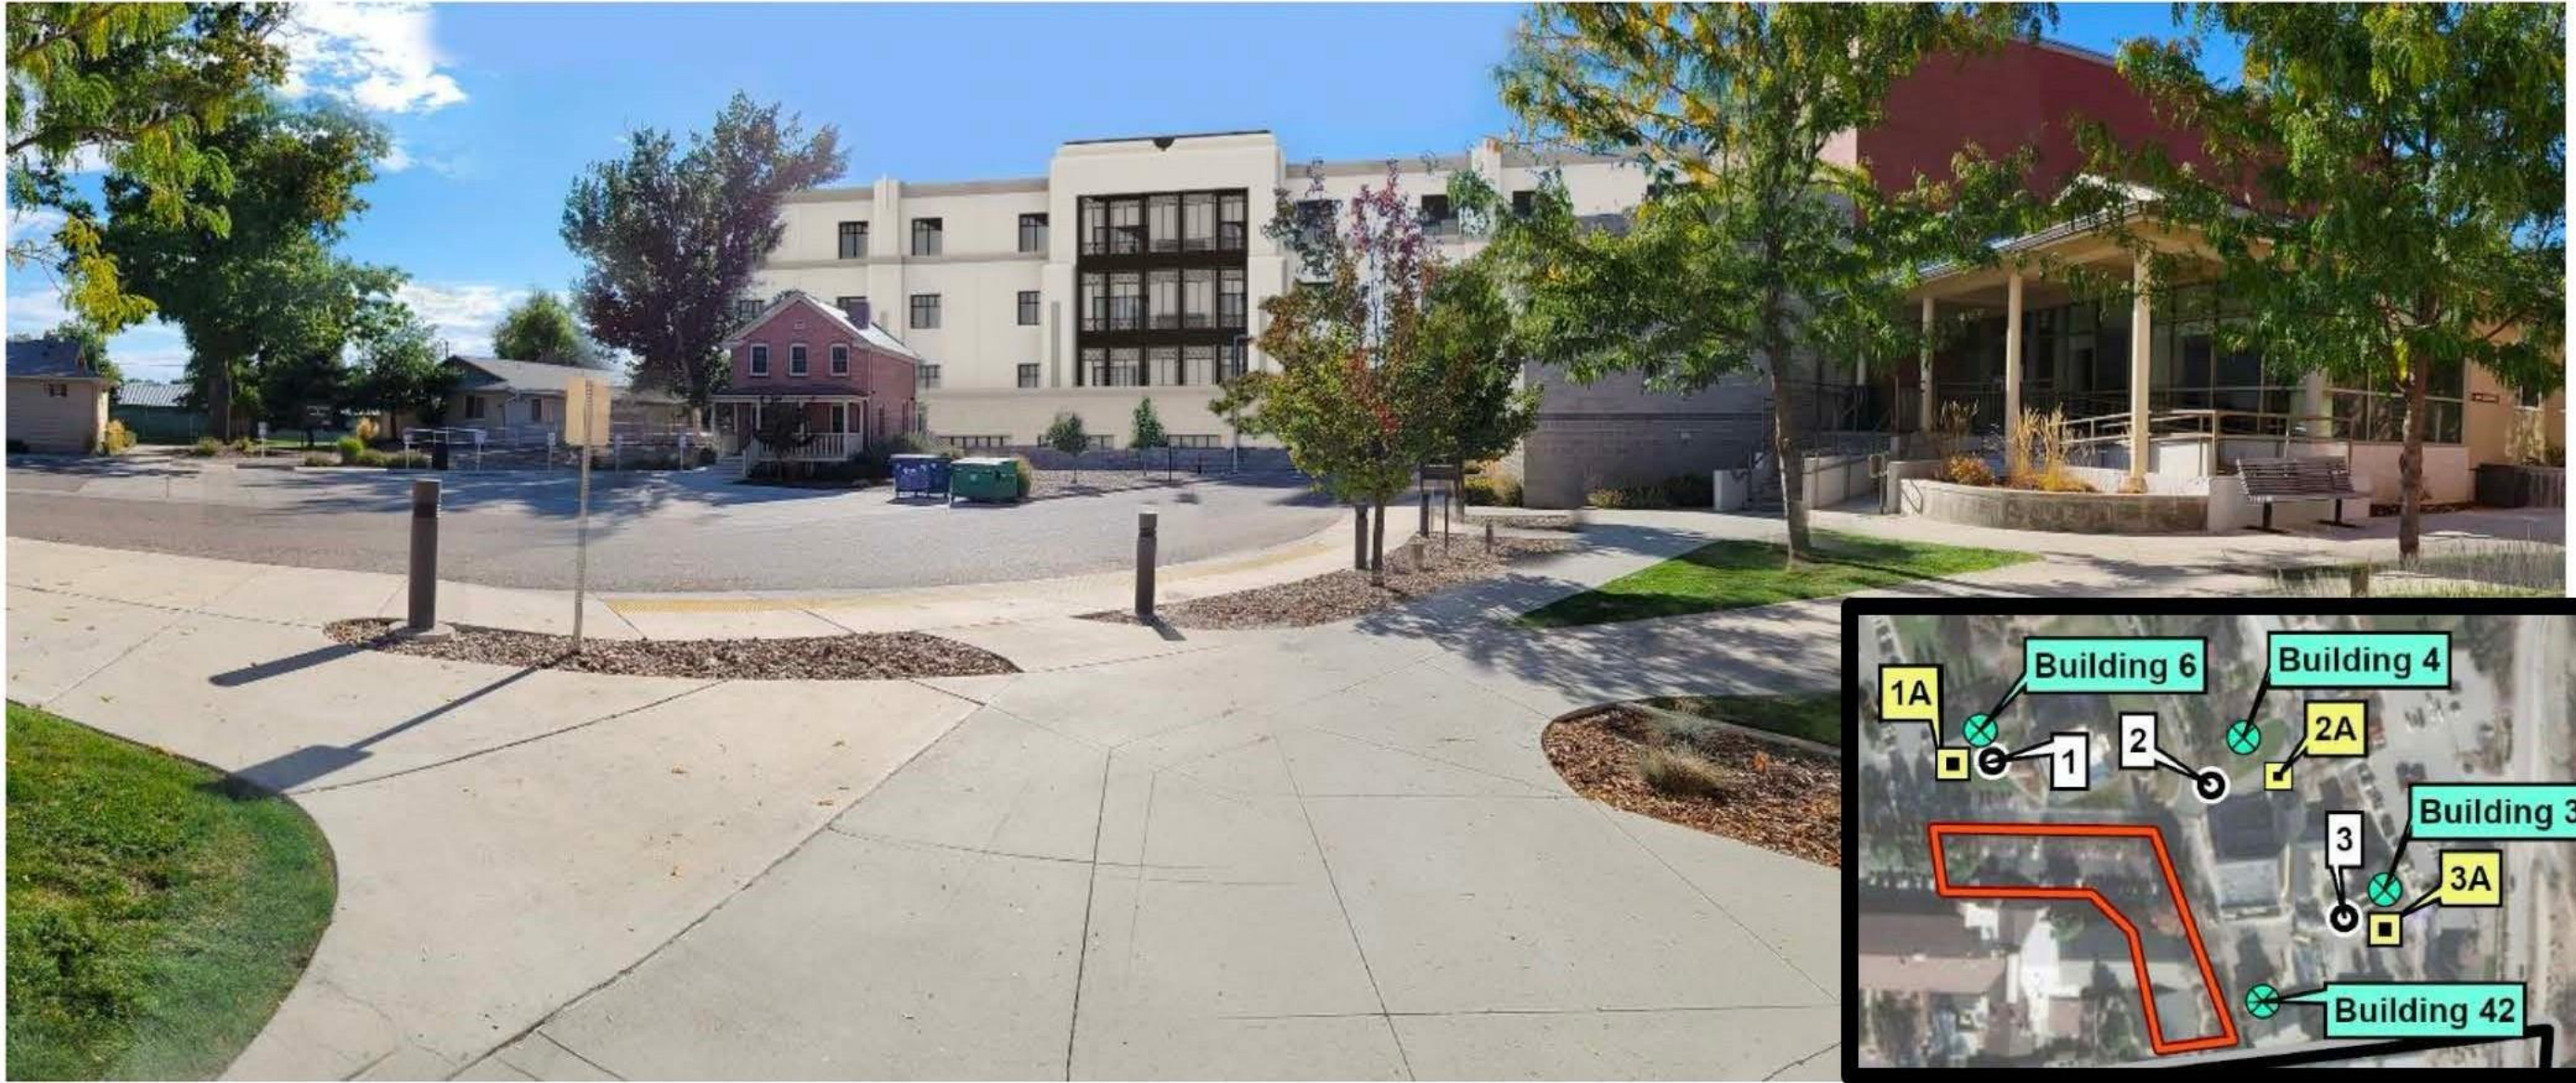
**Figure A-8. View of proposed building from Building 33 (rendering view 3A, Figure 2-A), looking west/southwest (photo courtesy of Orcutt/Winslow).**

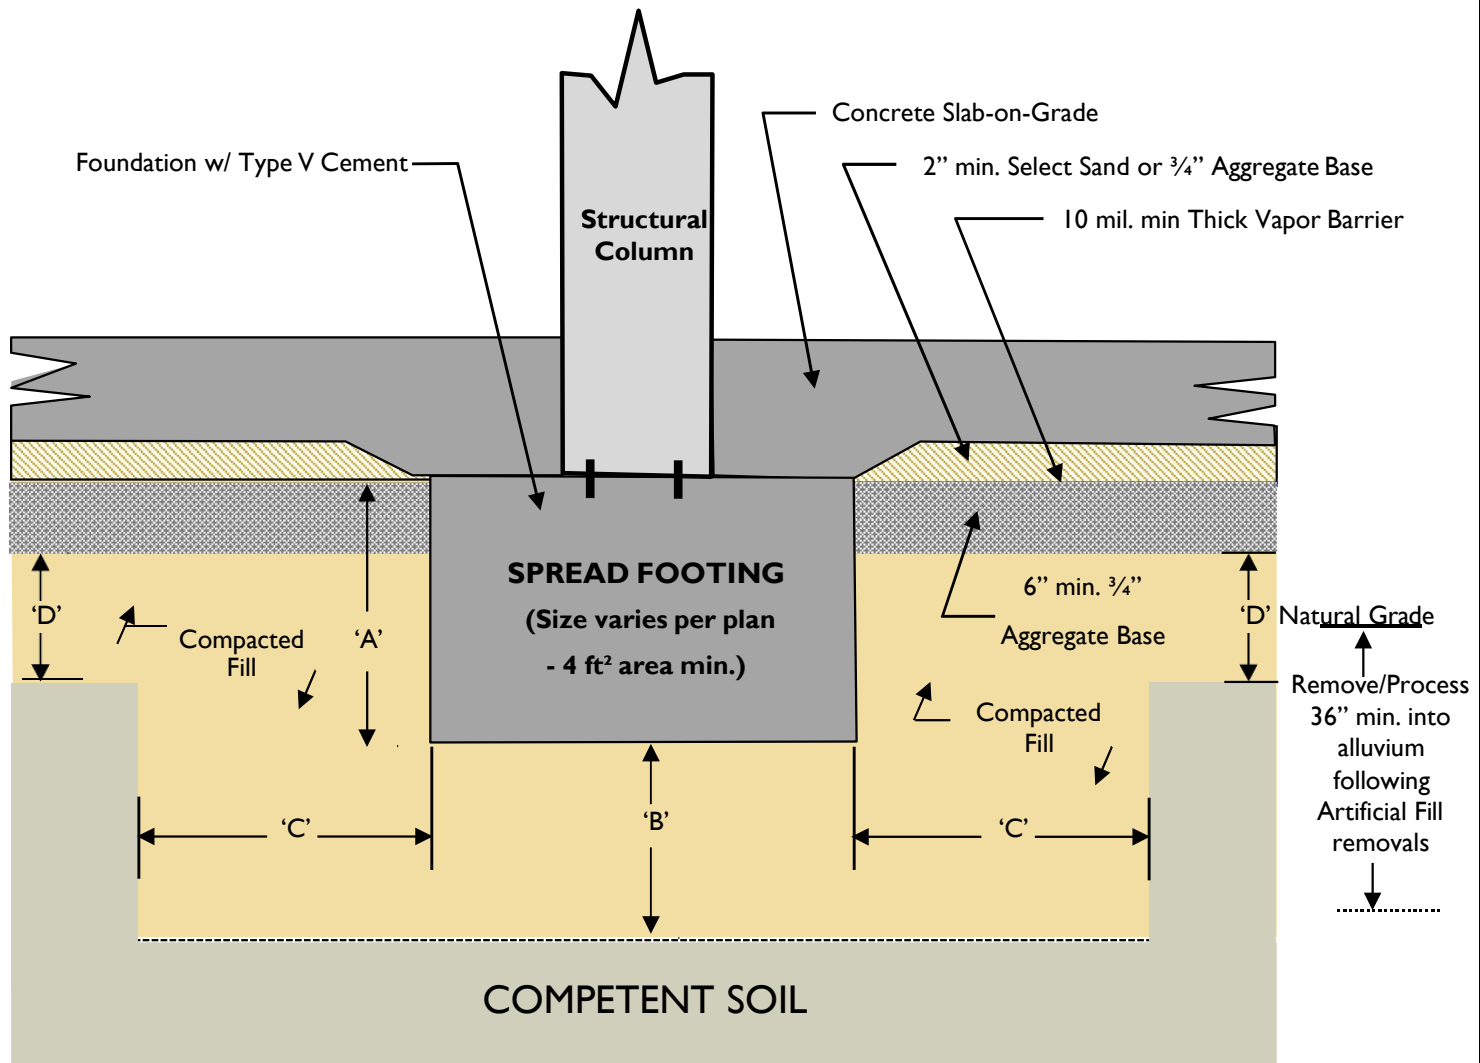
**NOT TO SCALE**

'A' – 24" min. Depth of Footing  
 'B' – 24" min. Compacted Fill Below Footing  
 'C' – 24" min. Compacted Fill Adjacent to Footing  
 'D' – 12" min. Compacted Fill Under Slab

**Note:** Concrete Slab shown is a "typical" detail only. Actual shape and dimensions to be designed by structural engineer and detailed in the project plans. The purpose of this detail is to show minimum footing depth, width, loose soil processing depths, and fill blanket thickness.

Beneath the foundations, a minimum of 24 inches of compacted structural fill, meeting the requirements of the Structural Fill and Import Soils section of this report, should be moisture conditioned and compacted to provide a more uniform foundation support. Structural fill should extend a minimum of 12 inches horizontally, from the edge of the footings, for each 12 inches of thickness placed below the footings.

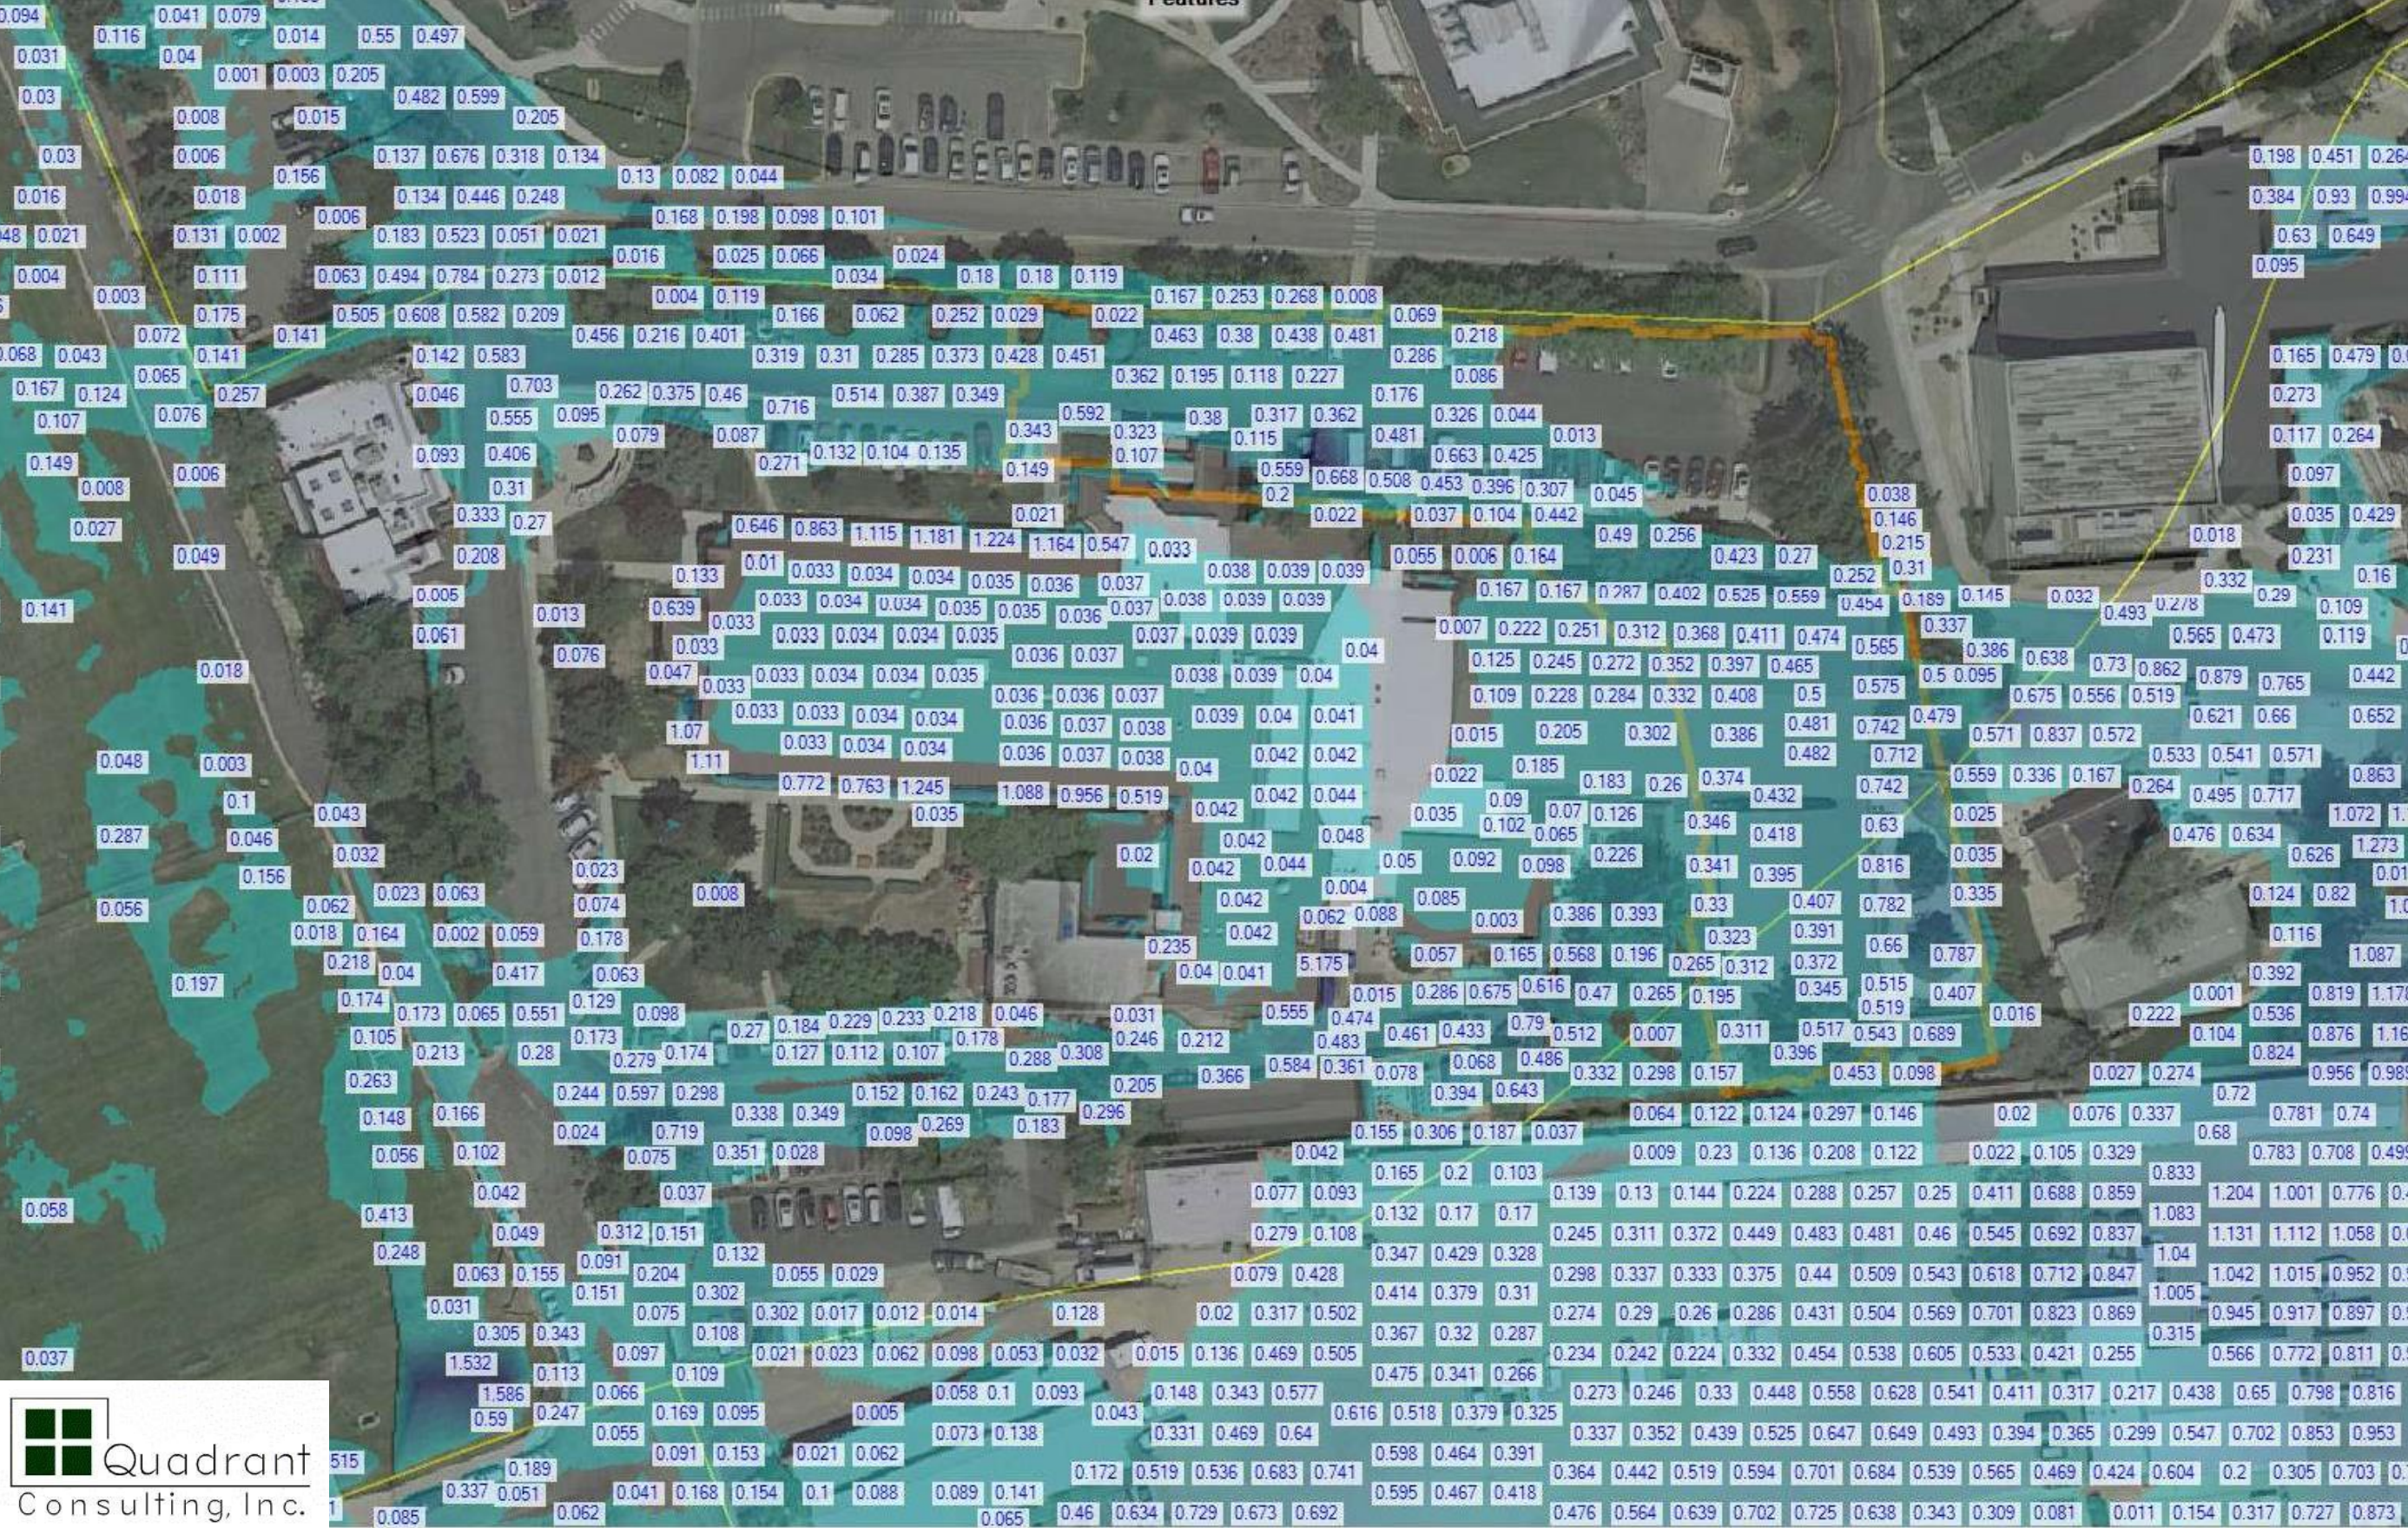
Veteran's Site - Existing Flooding Conditions 2D Model (Depth) - 3-23-23

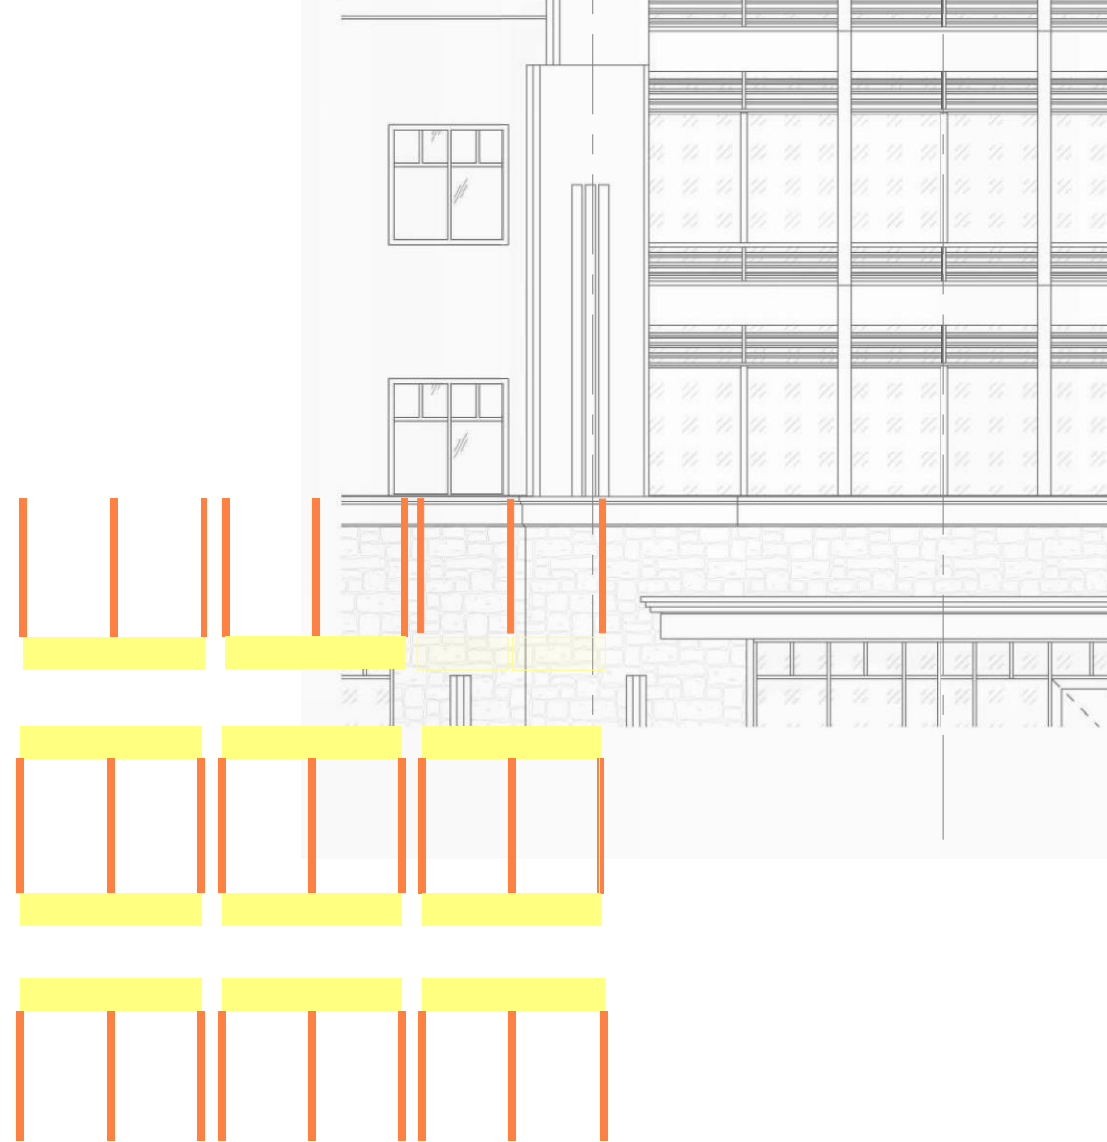
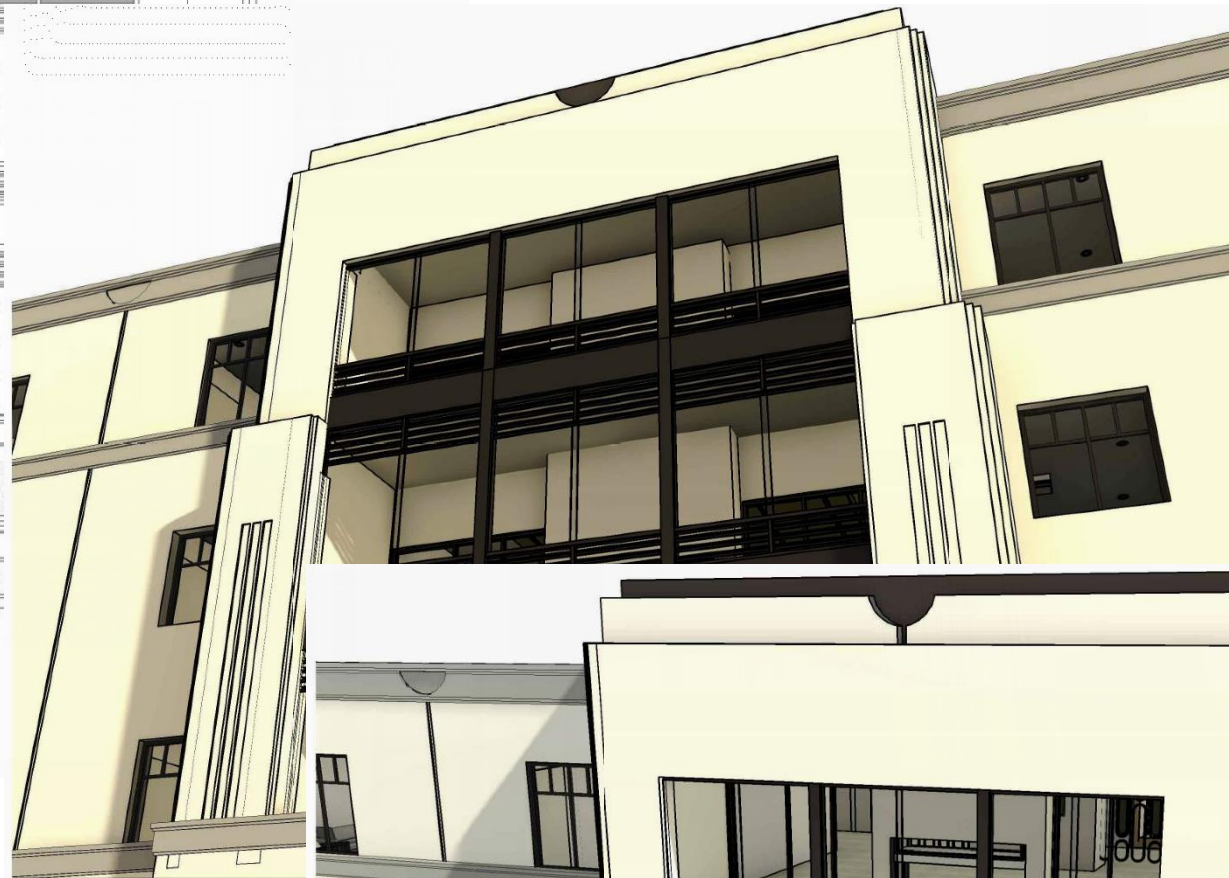
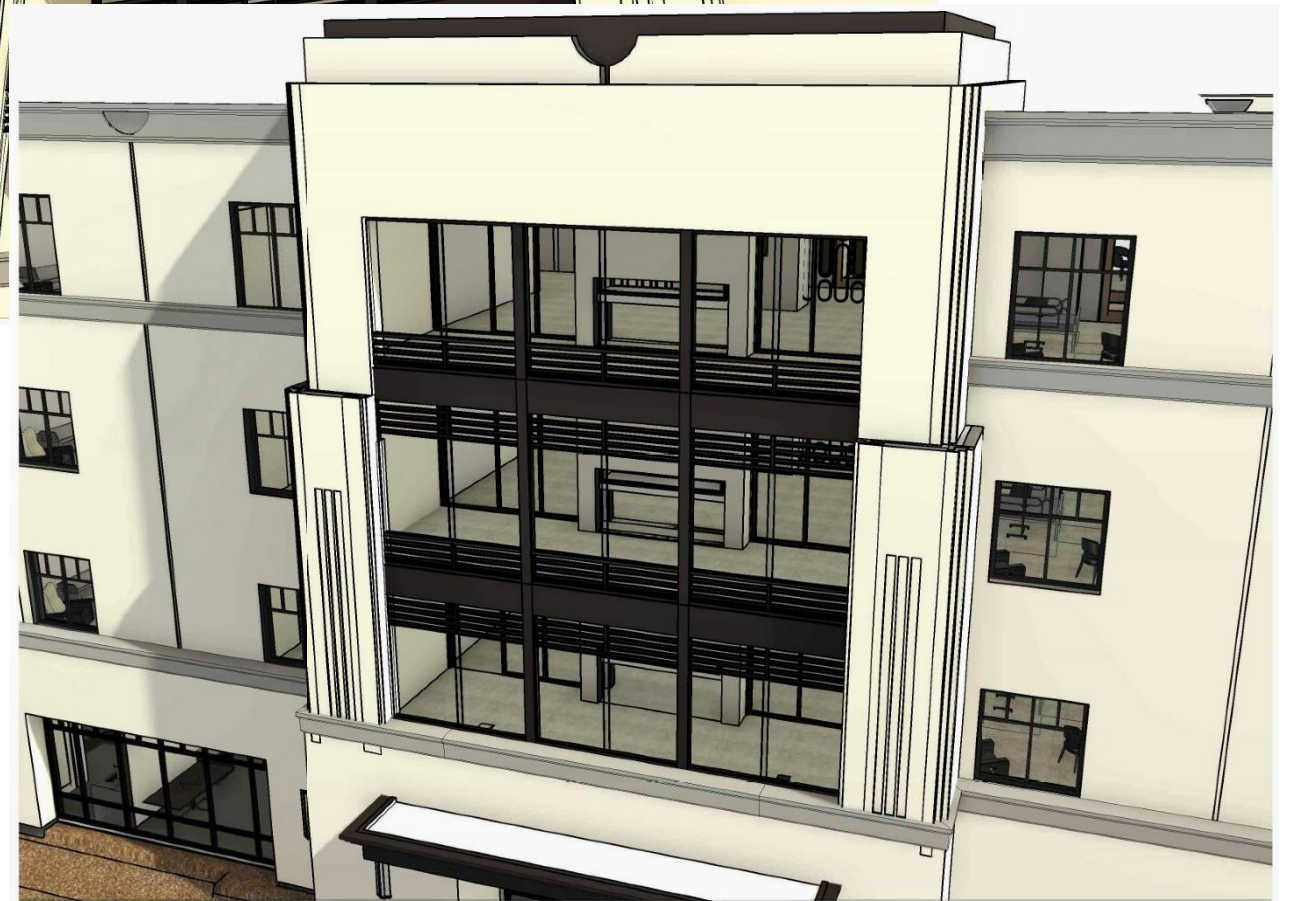
**OPTION 1 - GLASS+BUILT-UP LOUVER SYSTEM (BASE PRICE)**

1. Built-Up louver system at the floor and ceiling
2. Painted in field
3. Glass panels mounted with a U-Channel on the HSS top rail
4. Louvers can tilted to discourage climbing

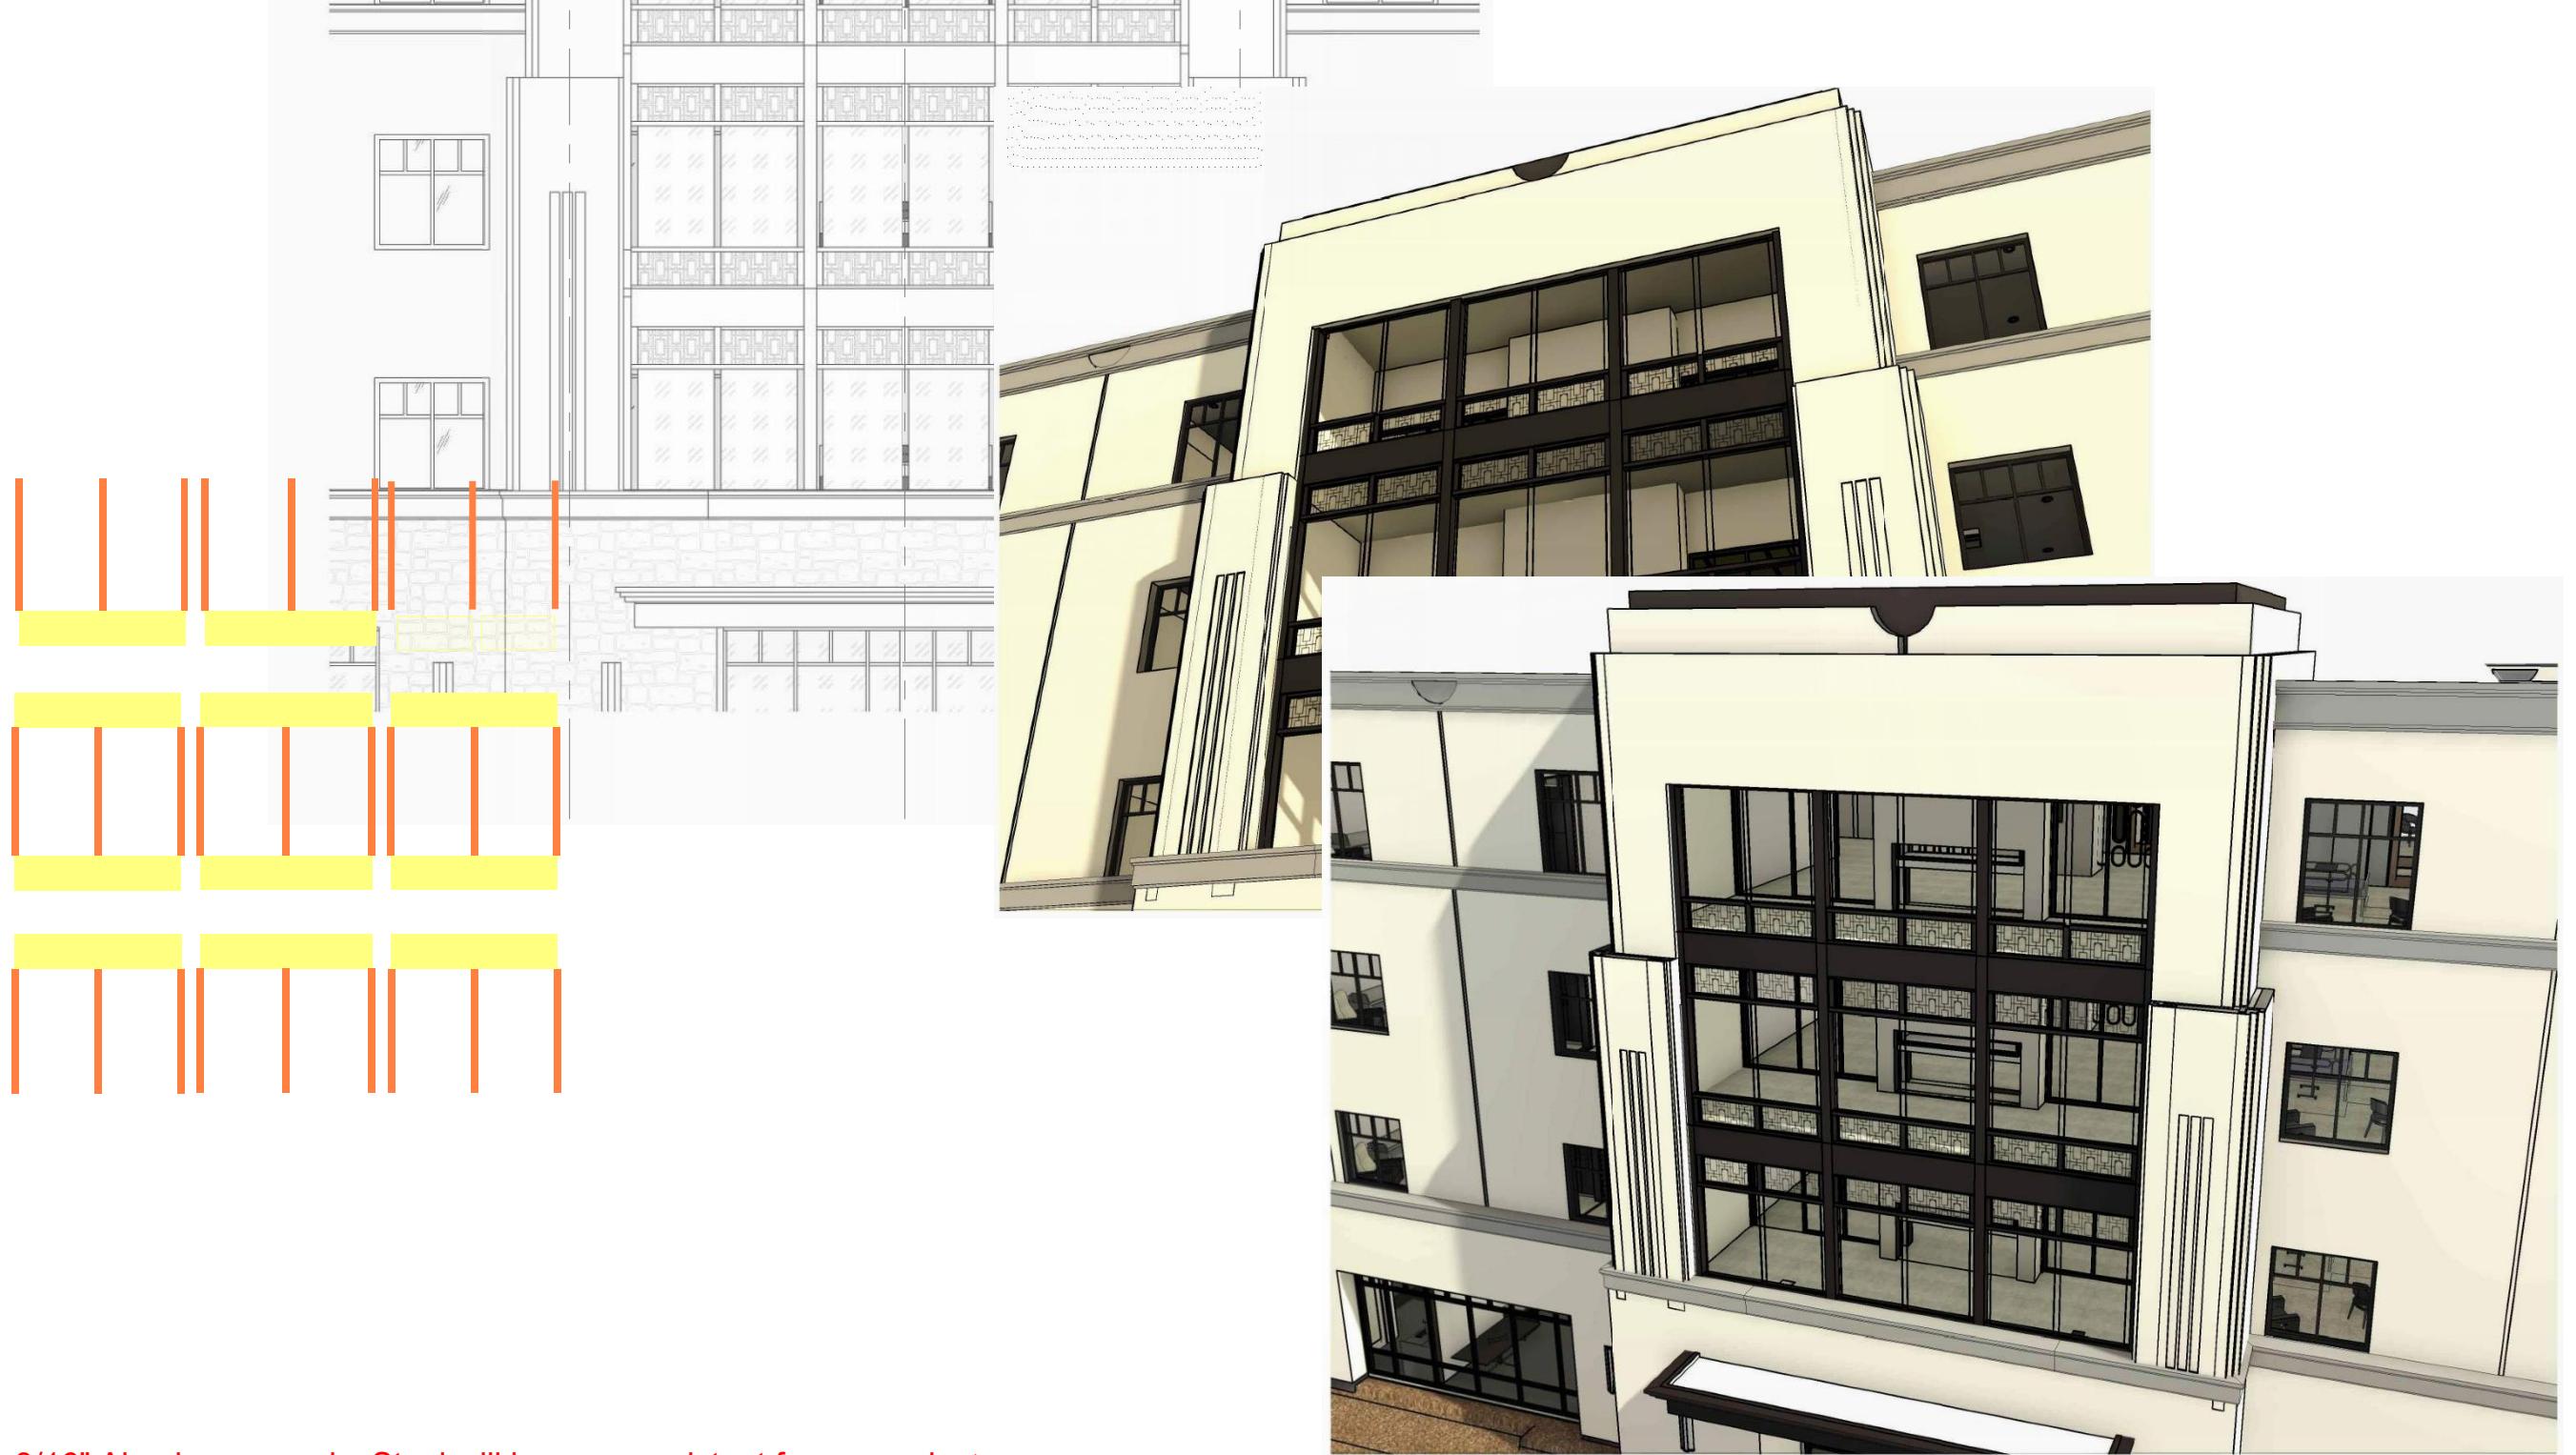
## **OPTION 2 - GLASS+METAL PANEL IN HSS FRAME**

1. 1/8" thick steel panels or 3/16" Aluminum panels. Steel will be more resistant for our project.
2. Panels can have a powder coat finish, or they could be unfinished, painted.
  - a. Powder coat is more difficult to maintain and repair as compared to paint touch ups.
  - b. Unfinished will be more cost effective.
3. The panels are designed for a 200 lbs. impact, similarly to a railing. Revamp Team will let us know if this impact is good enough for scooters.
4. The Panels are not easily 'dentable' – the concern of scooters running into them, and damaging could be alleviated with 1/8" thick steel panels.
5. Concealed installation system will be more expensive than the standard exposed connection system using 'L'-shaped angles.

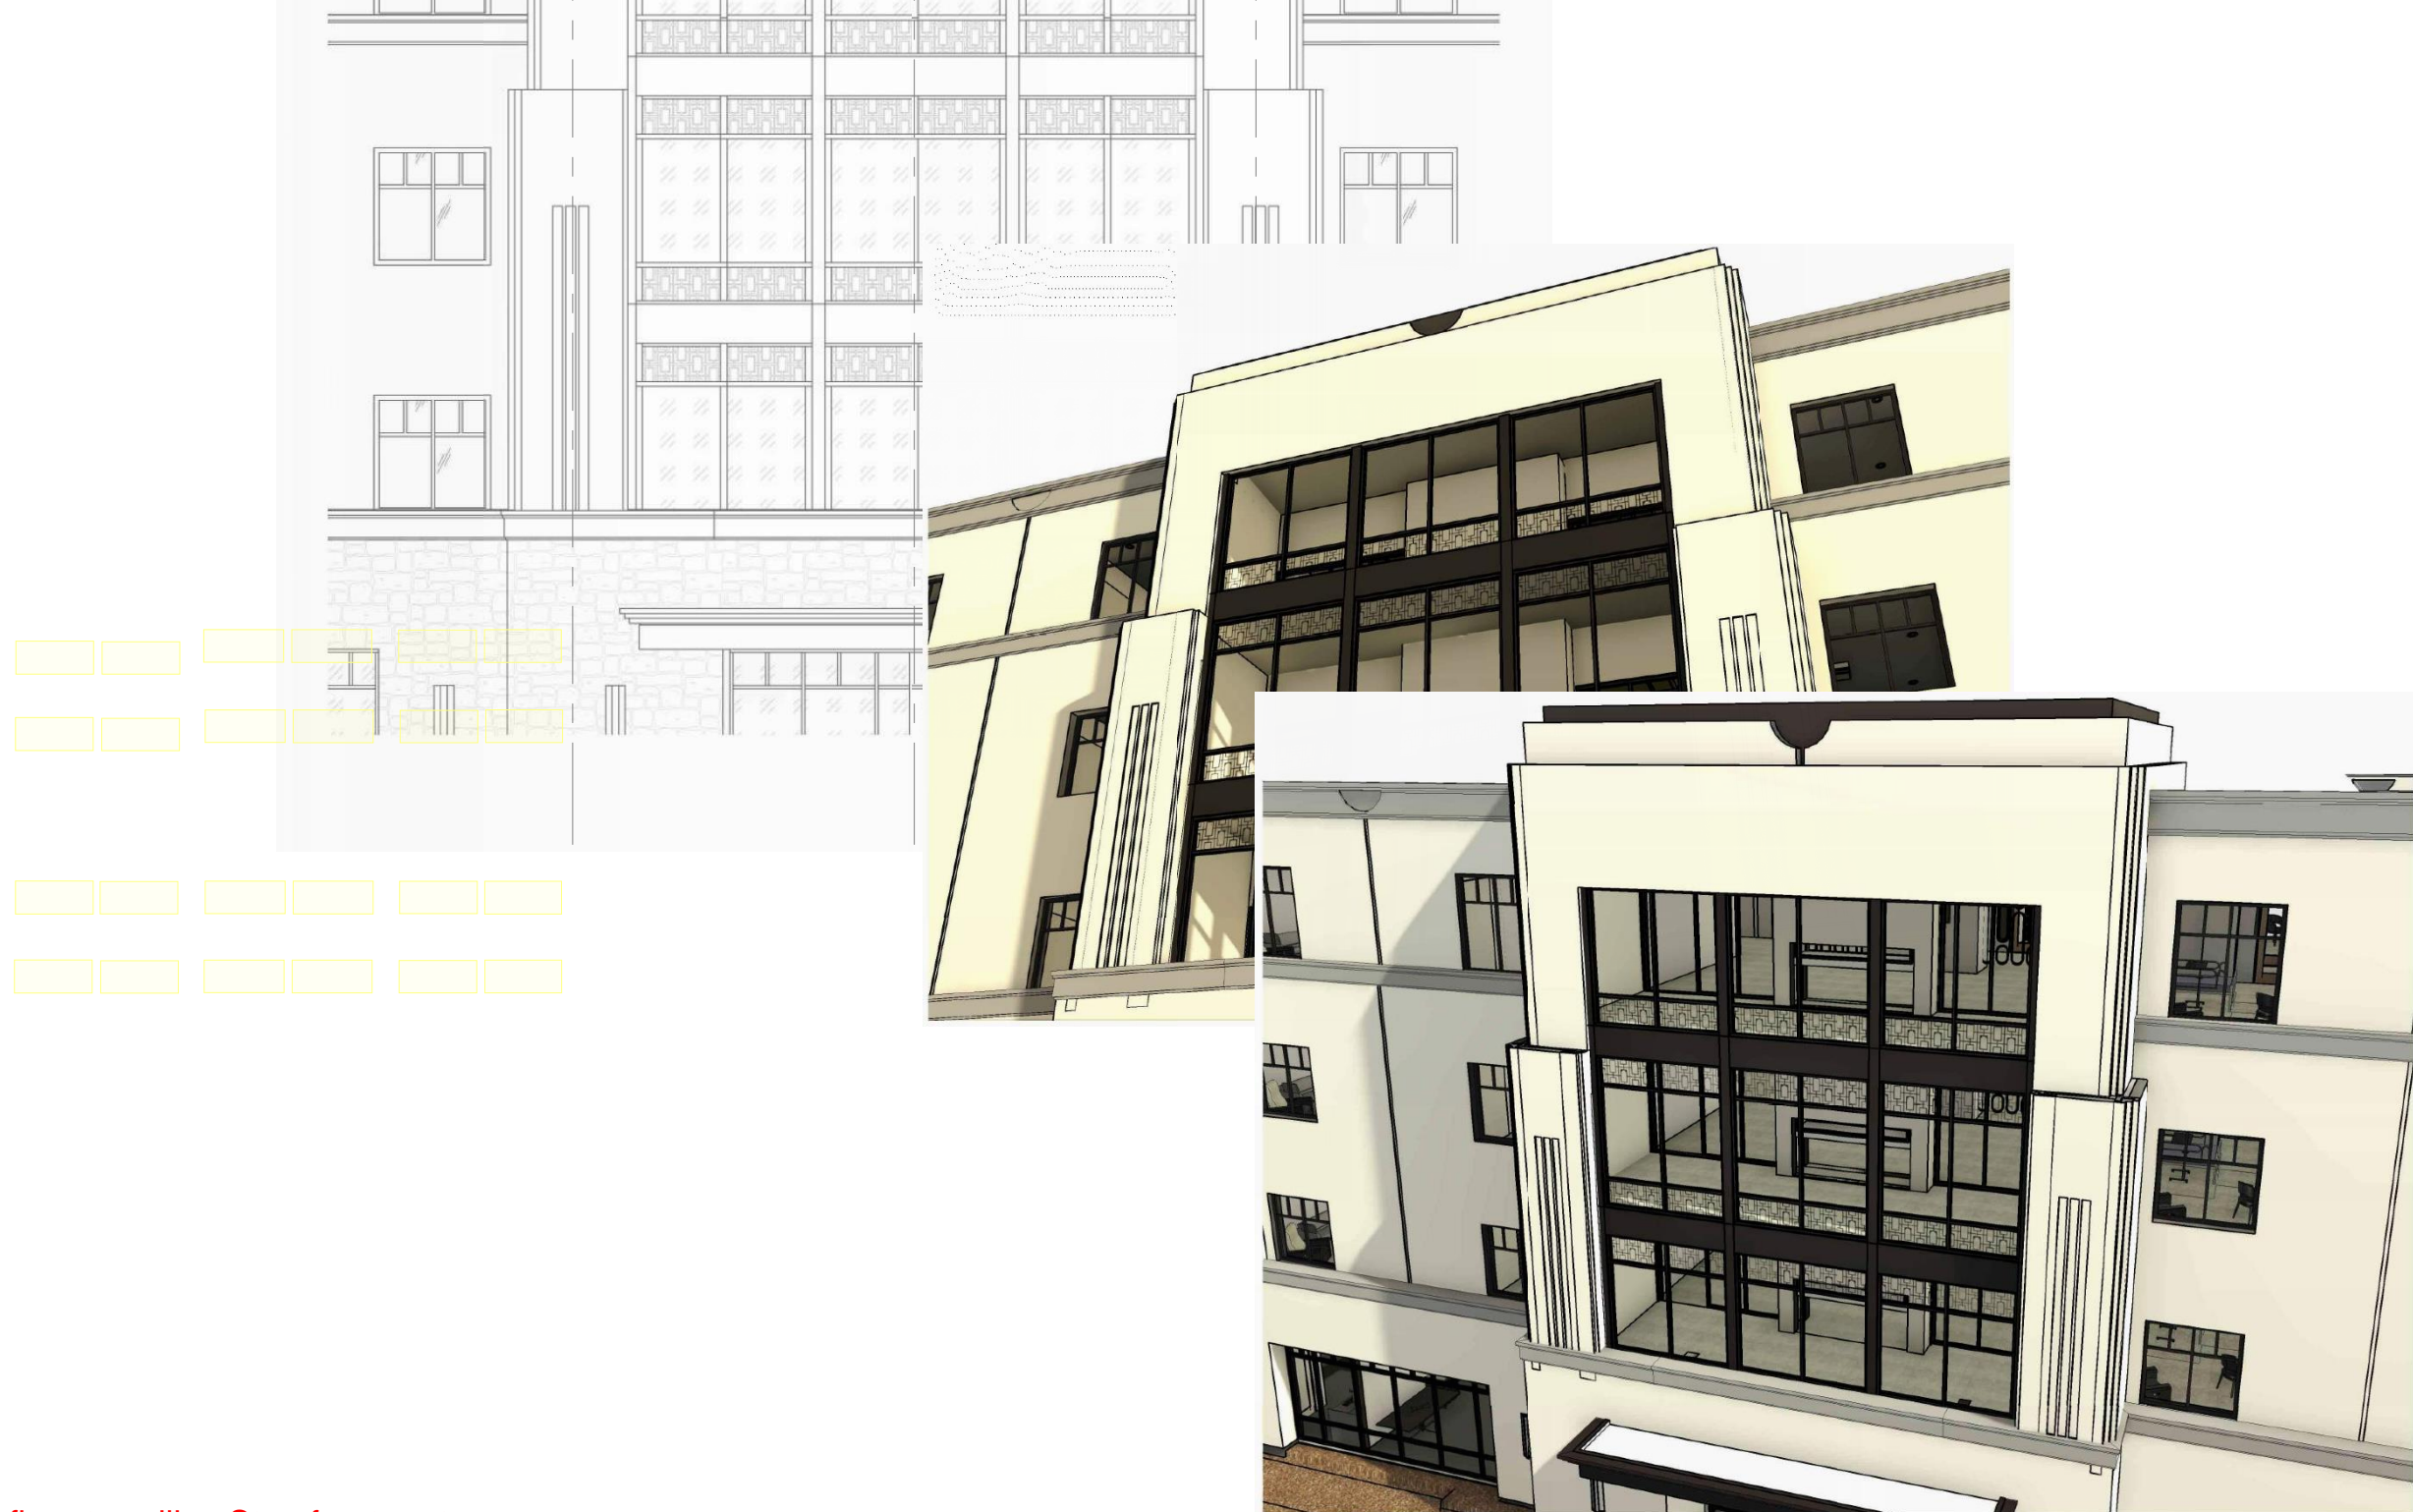
### **OPTION 3 - METAL PANELS IN STOREFRONT SYSTEM**

1. Metal Panels in a floor to ceiling Storefront system
2. The storefront can come with the framework and the glass panel in the center. the space above & below can be left open to install the metal panel
3. Can use single pane glass as it is unconditioned
4. This option provides a good balance of a simple storefront frame and metal panel infill
