## **APPENDIX A**

### **AIR QUALITY**

# Idaho State Veterans Home - Boise

STATE HISTORIC PRESERVATION OFFICE  
COMMUNITY PRESENTATION

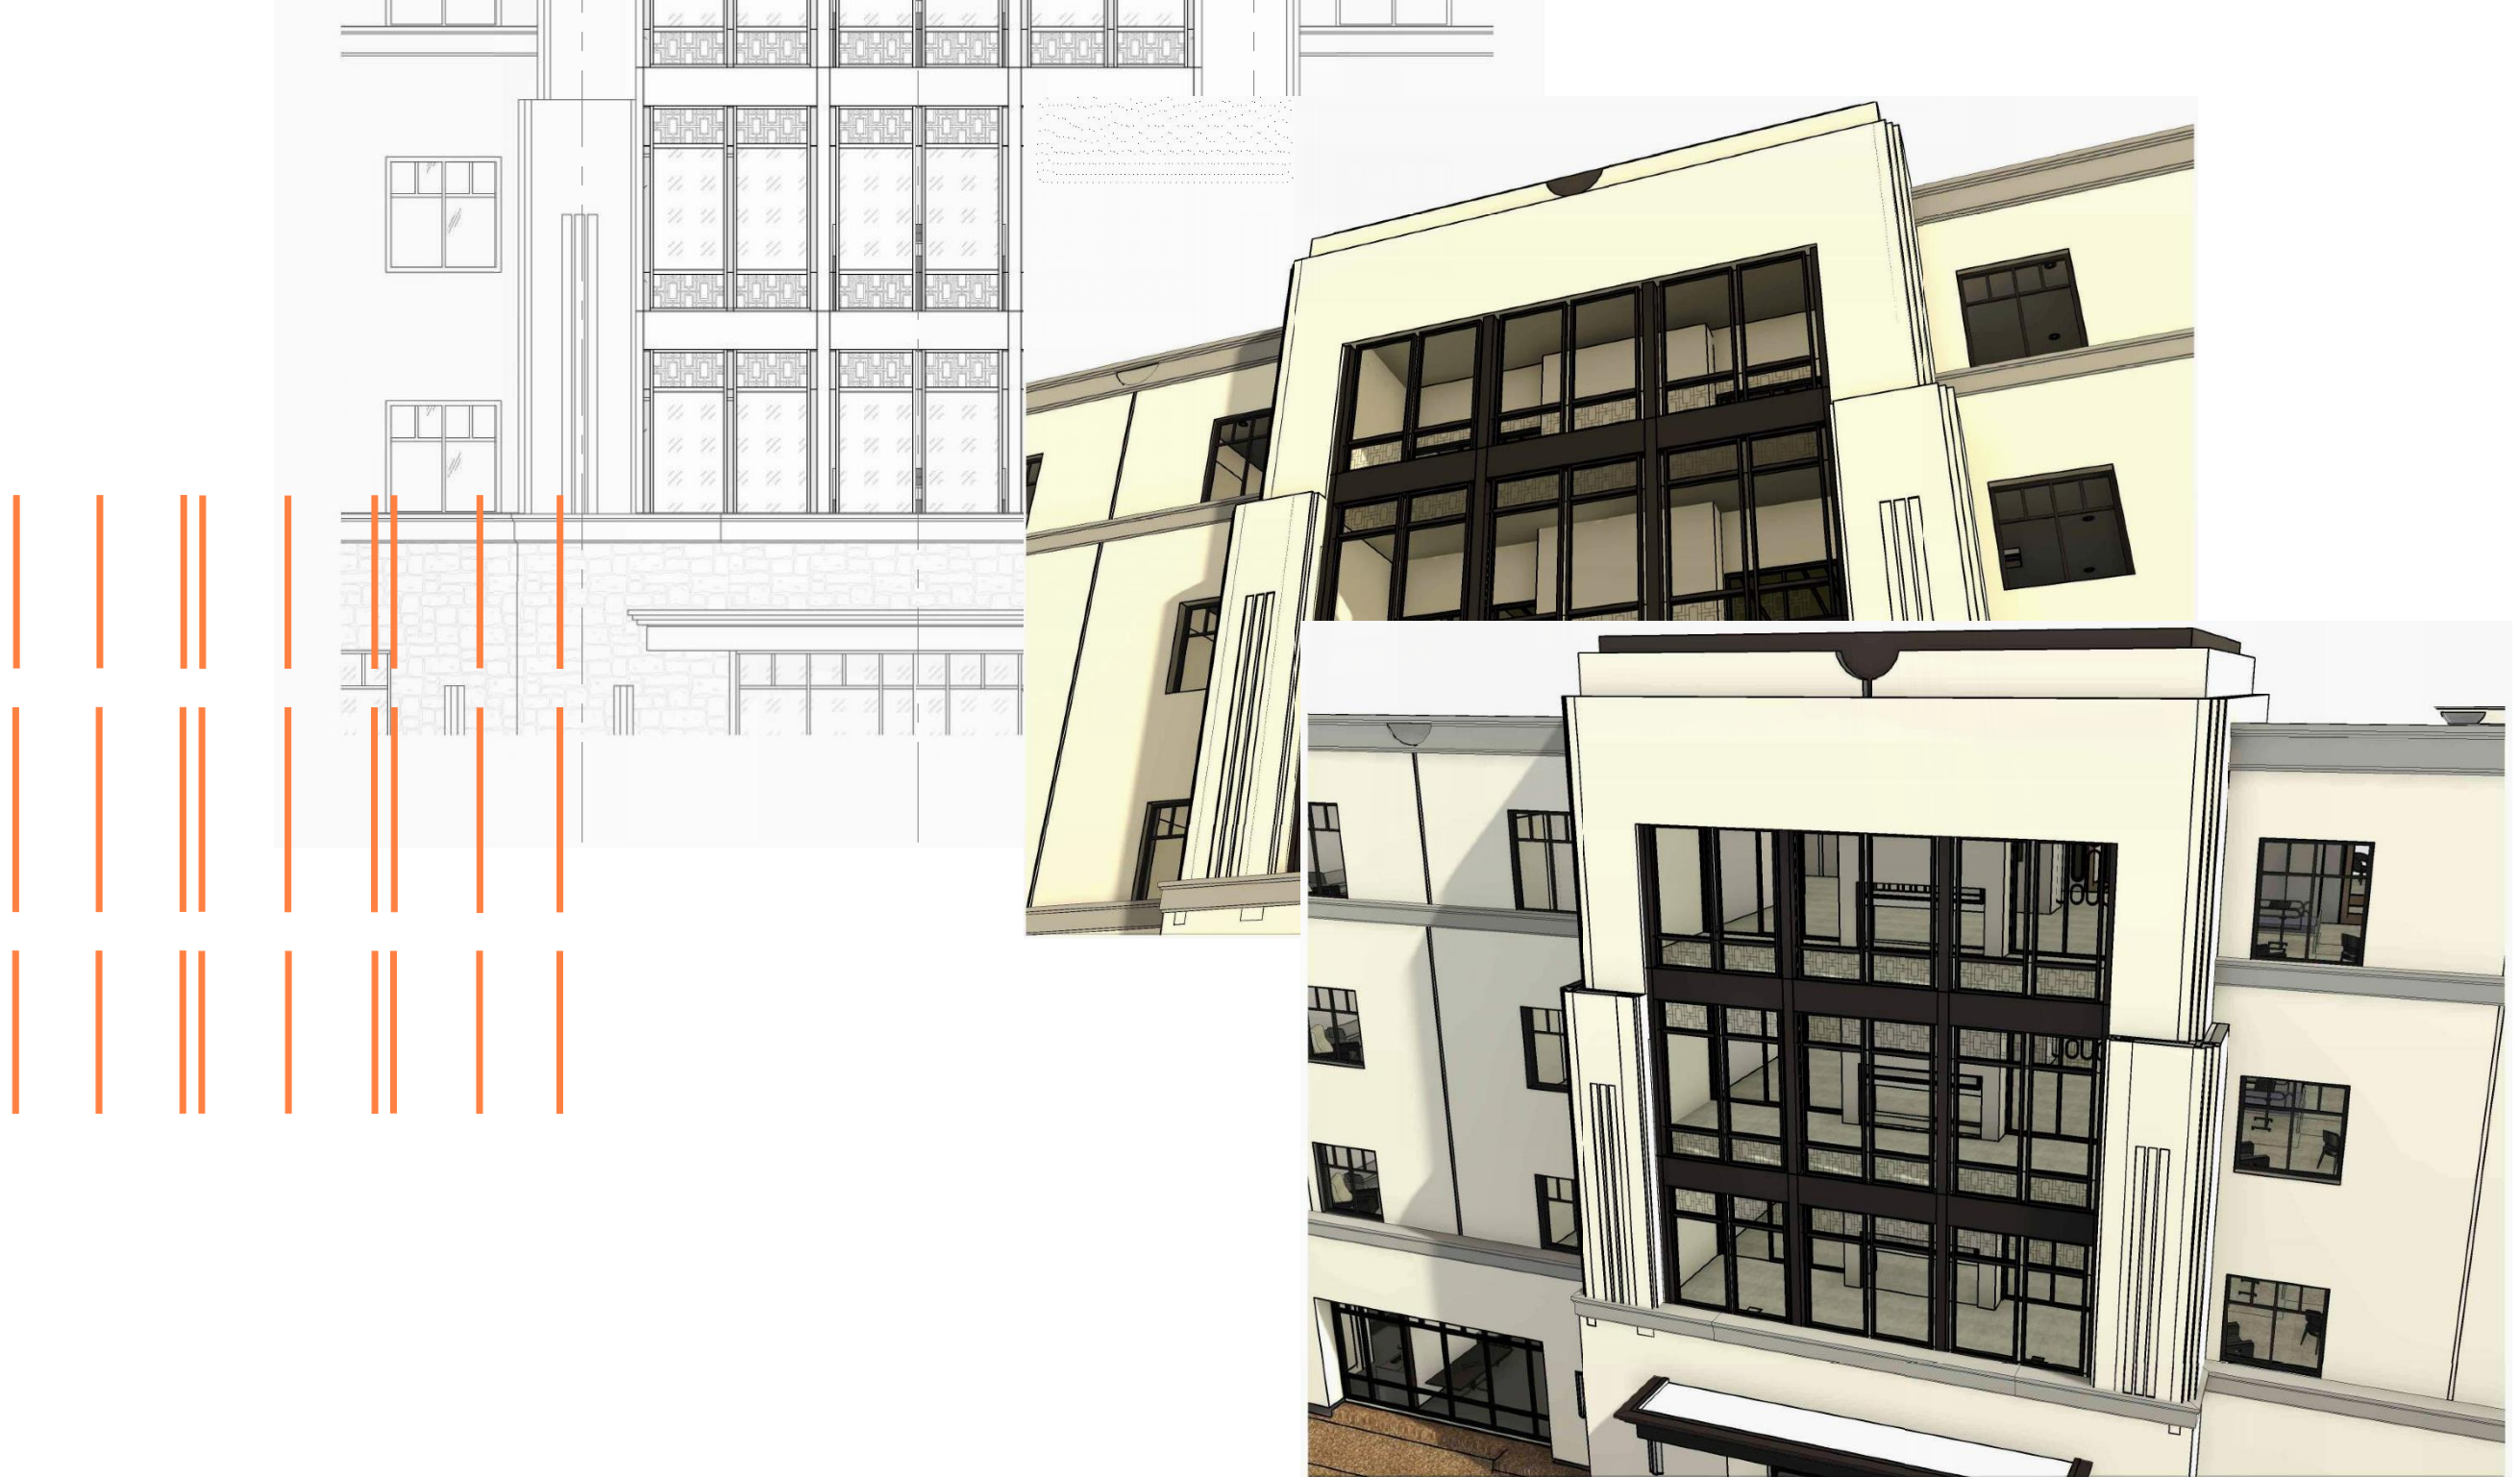
#### **OPTION 4 -PATTERNED GLASS IN STOREFRONT SYSTEM (VERTICAL GAPS)**

1. Patterned glass in lieu of Metal Panels in a floor to ceiling Storefront system
2. Option uses insulated glass to allow the film to be surface 2 or 3 for protection
3. The glass can be tempered at the floor level - this is not a big cost impact
4. Storefront will be secured at head and sill (and not jamb) - need to verify with Storefront Mfr.
4. Code requires a min. 4% of the unconditioned floor area for natural ventilation - this option has 6.9%

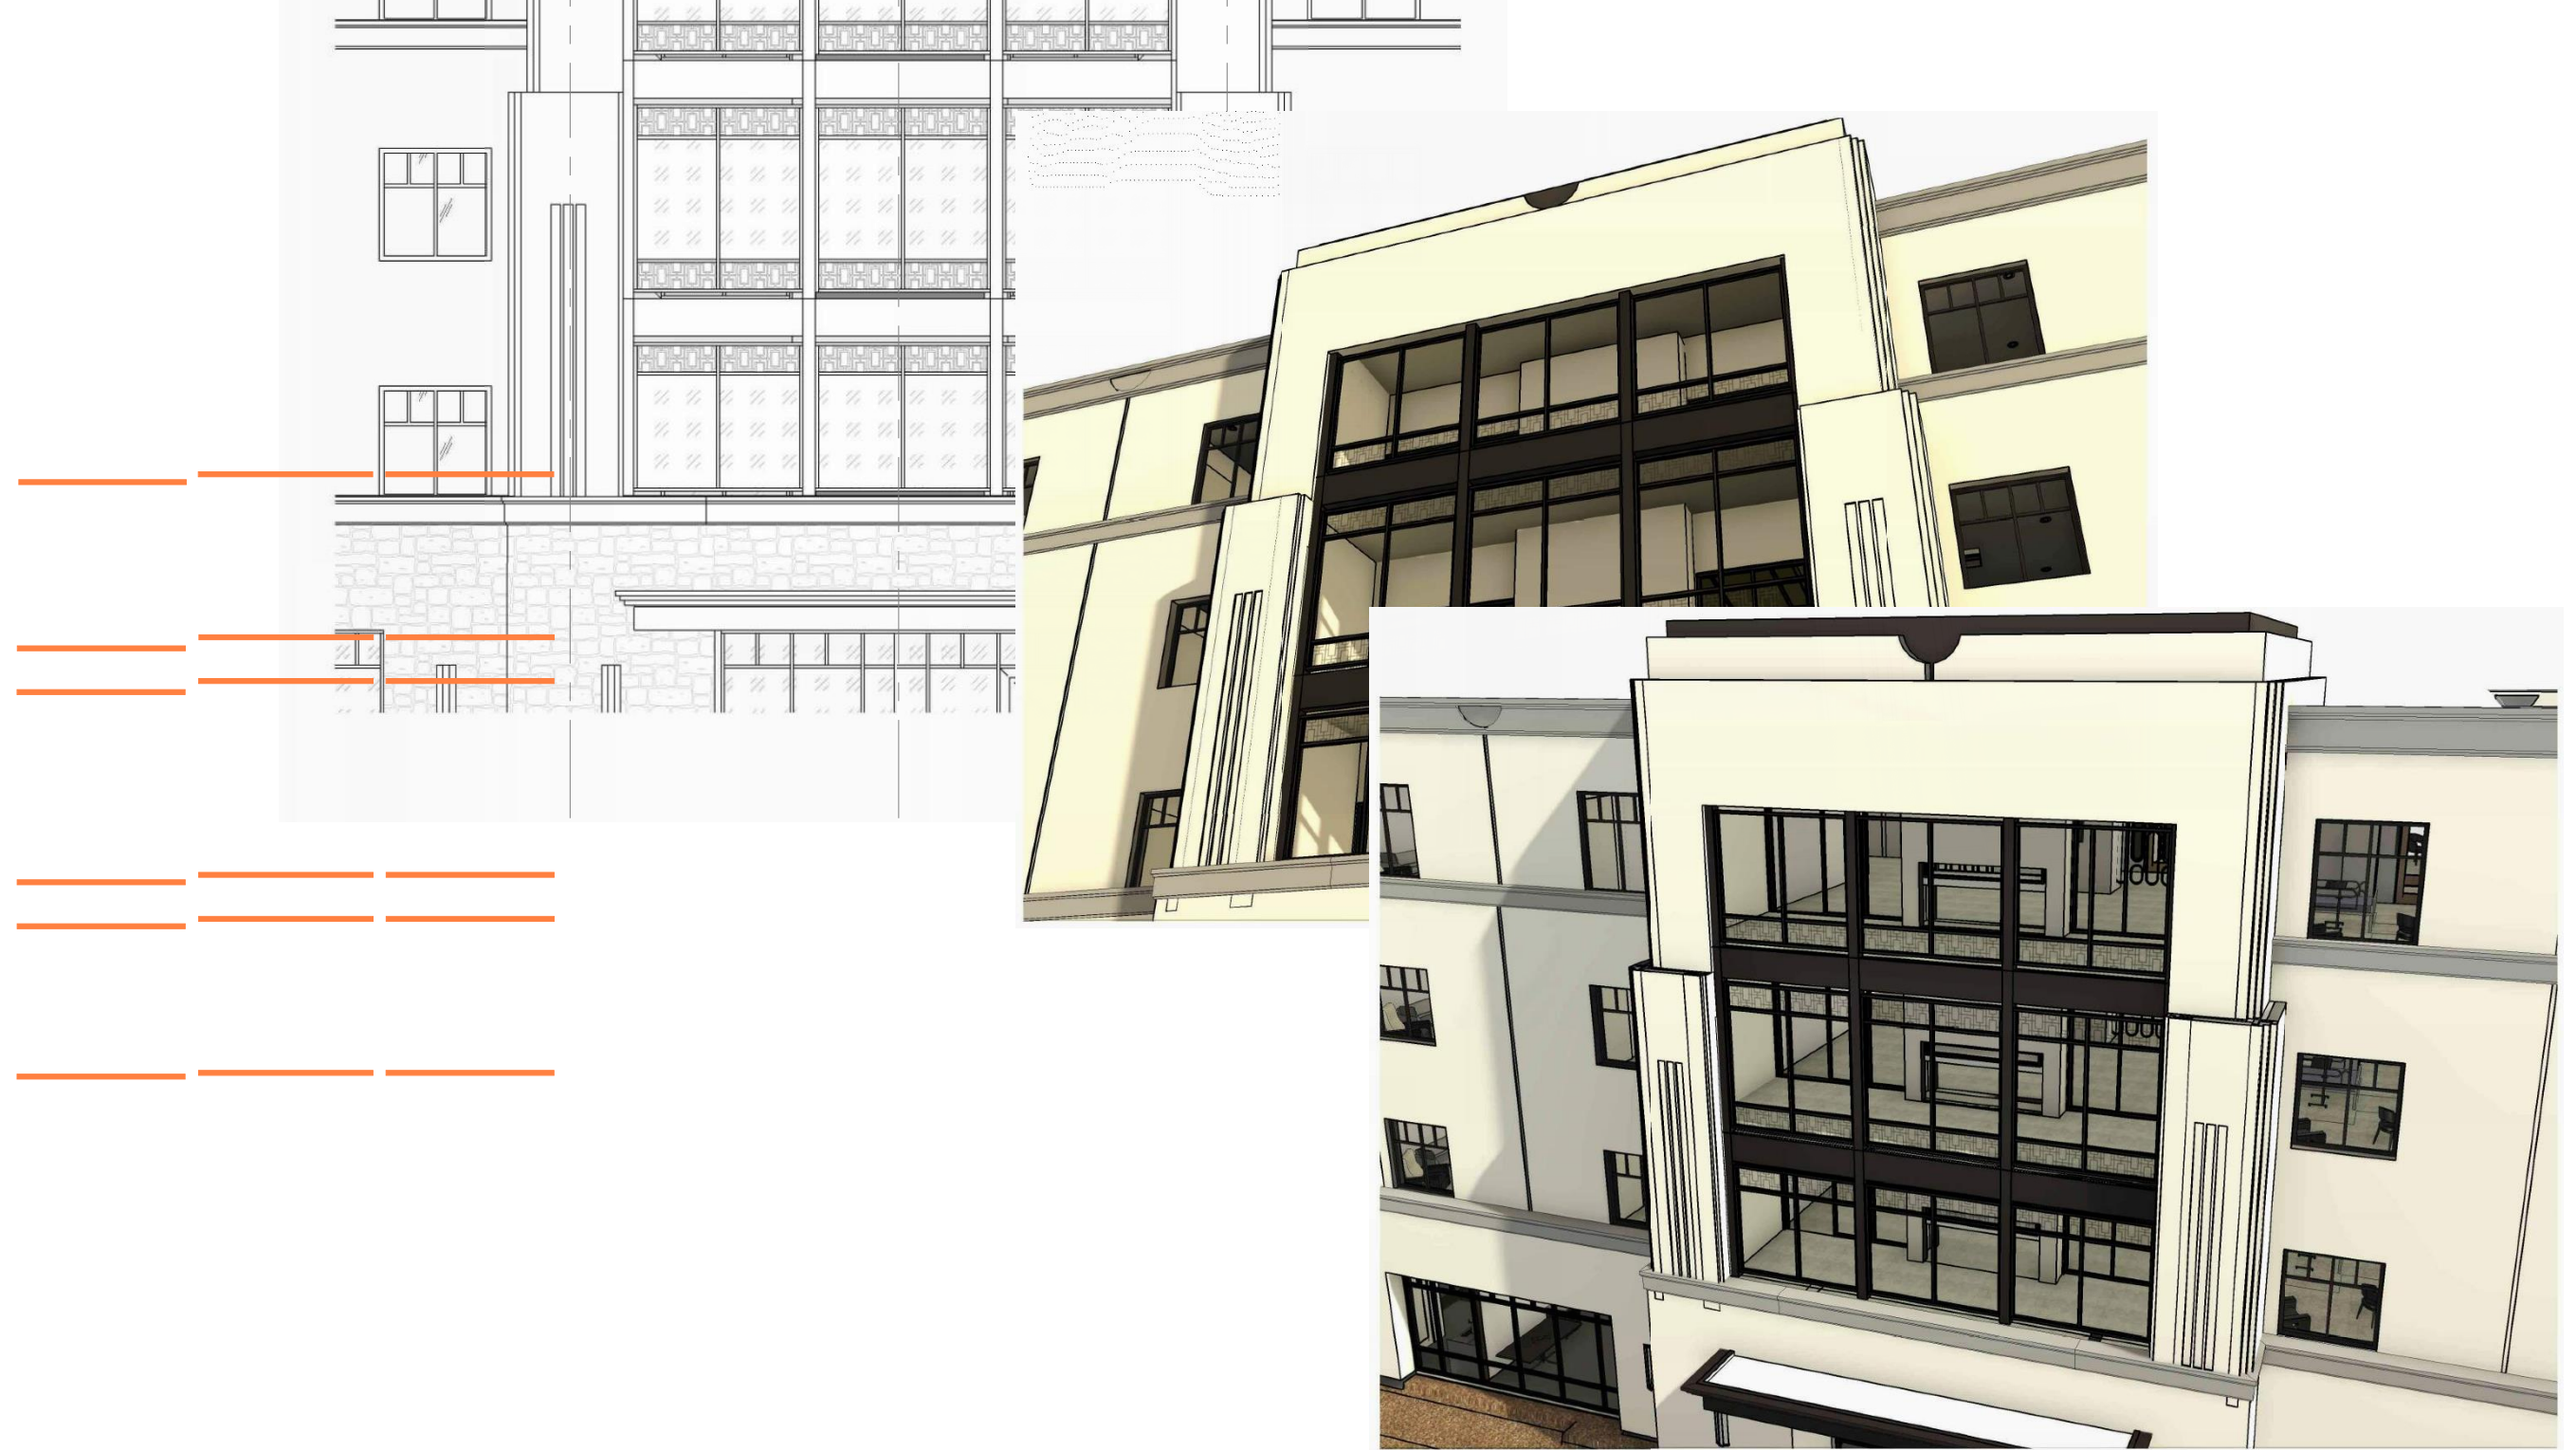
### **OPTION 5 - PATTERNED GLASS IN STOREFRONT SYSTEM (VERTICAL GAPS)**

1. Patterned glass in lieu of Metal Panels in a floor to ceiling Storefront system
2. Option uses insulated glass to allow the film to be on surface 2 or 3 for protection
3. The glass can be tempered at the floor level - this is not a big cost impact
4. Storefront will be secured at the jambs - need to verify with the Storefront Mfr.
4. Code requires a min. 4% of the unconditioned floor area for natural ventilation - this option has 4.6%. (The least air flow between all the options)
5. Additional framing will be needed through the horizontal air gaps at the top and bottom for support. Whether this is part of the storefront or other supporting materials, will need TBD.
